**CHEVROLET MOTOR DIVISION**  
 General Motors Corporation  
 Chevrolet Service Department

**Chevrolet  
 Dealer  
 Service  
 Technical  
 Bulletin**

67-T-15  
 Number:  
 Ia  
 Section:  
 March 6, 1967  
 Date:

Subject: **FOUR SEASON AIR CONDITIONING  
 INFORMATION - CHEVROLET AND CAMARO**

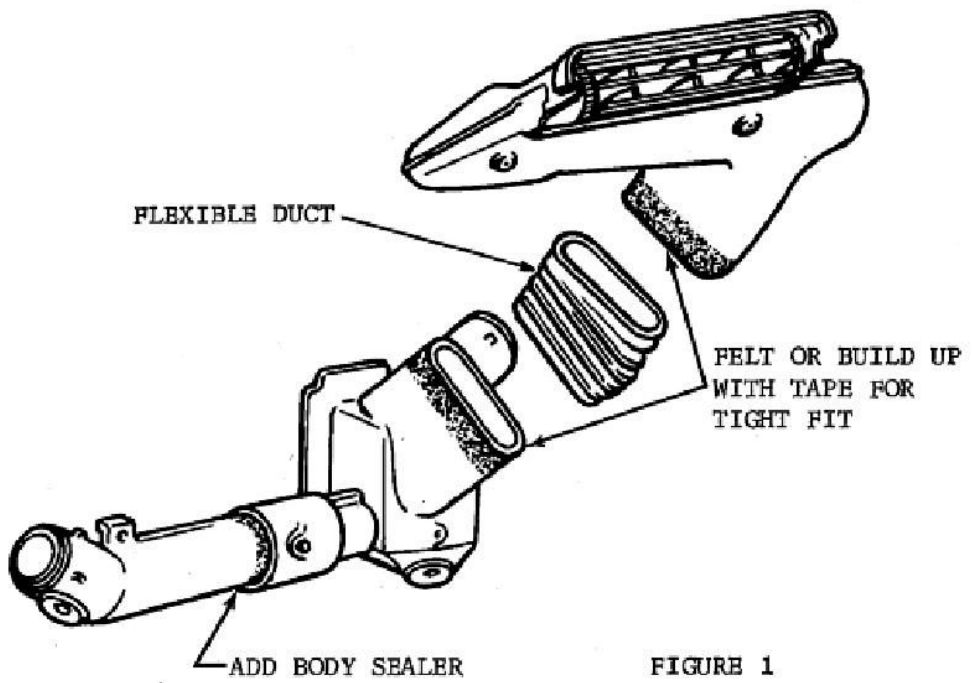
FIGURE 1

Some owners have expressed dissatisfaction with a lower volume of air coming from the side air outlets than in past years. The 1967 air distribution ducts have been designed to provide for improved rear seat cooling by having more air flowing out the center console duct. If the air volume at the side outlets is exceptionally weak, the duct system should be checked for possible air leaks at all connections. As necessary, duct joints should be taped and sealed. (Refer to Figure 1).

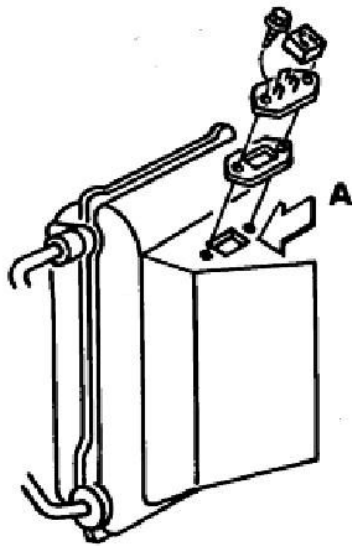
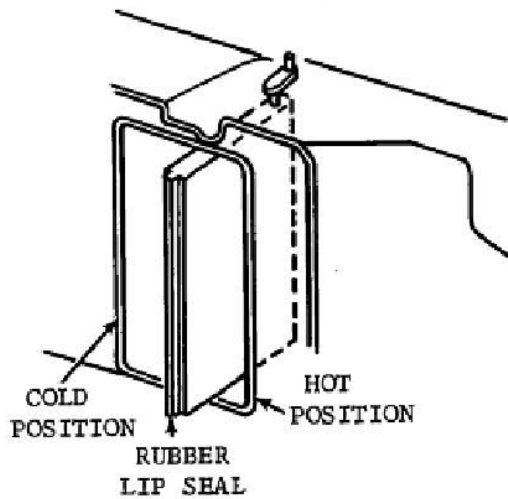
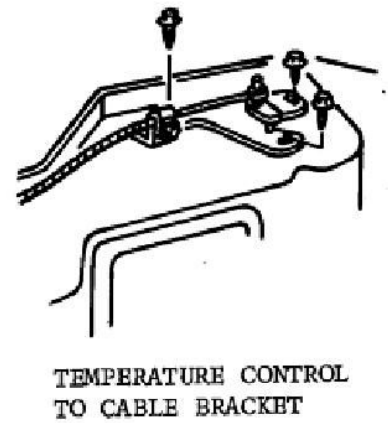
FIGURE 2

Poor temperature control is generally caused by a misaligned temperature valve door. If poor cooling or heating is encountered, the valve door should be checked.

Remove the blower motor resistor from the evaporator housing and inspect, with the aid of a light through the resistor hole, the alignment of the door to housing in both the cold and hot positions (Refer to Figure 2). A properly adjusted door will have the rubber lip contact the seal against the white die cast housing for the full length of the door.

If the temperature valve door is properly adjusted, refer to the 1967 Chassis Service Manual for other possible causes of poor cooling. If the valve door is improperly adjusted, proceed as follows.

1. Disconnect battery ground cable.
2. Remove glove box interior.
3. Adjust temperature valve door by:
  - a. Loosen (3) screws which attach the temperature control cable mounting bracket to heater case.
  - b. Check to assure the bracket can move freely and that the control cable is routed between the defroster duct and the dash.

- c. Cycle the temperature control lever from maximum cold to maximum hot and back again. This should cause the door to center itself and relieve excessive tension at either end of its travel.
- d. Tighten one screw in the cable mounting bracket and view the operation of the valve door through the resistor hole.
- e. If the gap remains between the door and the housing, loosen the cable bracket and rotate it until the gap is eliminated. Recheck door travel.
- f. Retighten cable mounting bracket screws. Caution should be taken not to overtorque the screws and cause stripping.

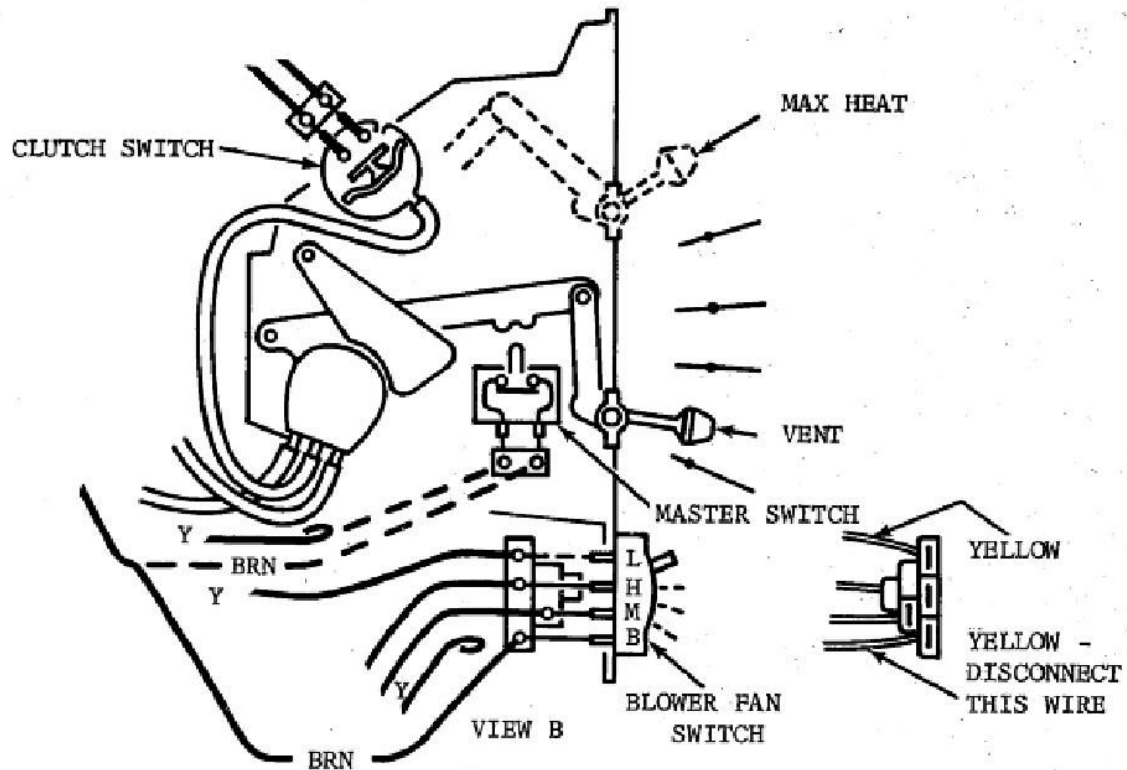
FIGURE 3

The design intent for the 1967 Four Season air conditioning system was to produce constant air circulation at all times. For this reason, a master switch was installed in the system that would cause the blower motor to run on low speed when the control lever was in the vent position.

If complaints of the blower motor running during outside air venting are encountered, the master switch should be removed from the circuit by following the procedure as outlined in Figure 3. This revised wiring will make the blower motor manually operated at all times.

1. REMOVE YELLOW WIRE FROM "B" TERMINAL OF BLOWER FAN SWITCH AND CUT THE WIRE TERMINAL OFF AND TAPE BACK.
2. REROUTE BROWN WIRE FROM MASTER SWITCH AND CONNECT TO "B" TERMINAL OF BLOWER FAN SWITCH.
3. REMOVE YELLOW WIRE FROM MASTER SWITCH AND CUT OFF TERMINAL, TAPE BACK WIRE END.
