# Chevrolet Dealer Service Technical Bulletin

67-T-6  
Number:  
I  
Section:  
Jan. 3, 1967  
Date:

Subject: BODY MODIFICATION

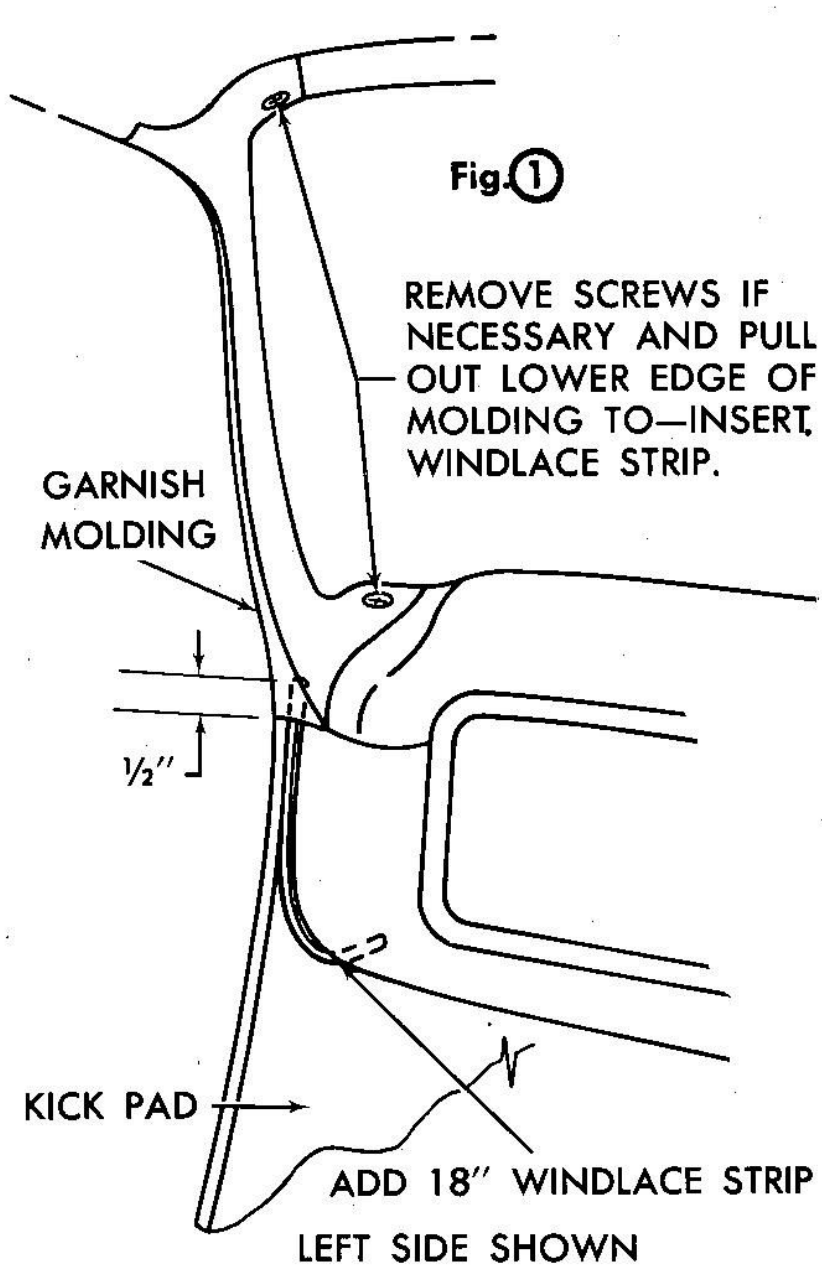
Instrument Panel to Hinge Pillar Fit - 1967 Chevrolet

In some instances, owners may complain about the amount of gap at the junction of the instrument panel to hinge pillar. This is particularly noticeable at night on vehicles equipped with under-the-dash courtesy lights. The condition results from the combined dimensional allowances in instrument panel and body widths. To satisfy owner complaints of excessive gap, windlace trim has been made available for service.

The open area is first filled with quick drying cement (3M - 1300 or equivalent), then the windlace assembly cut in 18" lengths and positioned under the garnish moldings as shown by Figure 1. Matching (color combination) windlace assembly part numbers are listed.

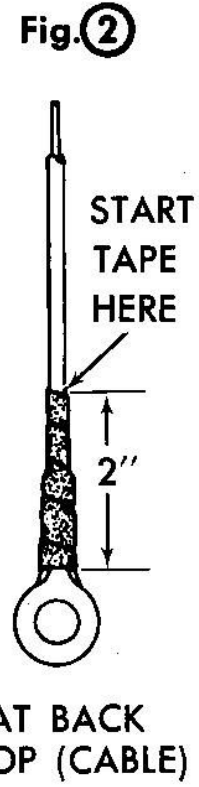
Bucket Seat Wear - 1967 Camaro and Corvair

In some instances, Camaros and Corvairs built prior to mid-October with bucket seats may experience seat side cushion seam wear due to a rough edge on the seat back stop cable terminal. The terminal eye attaches to the back side of the outer seat hinge.

If a rough edge exists on the seat back stop cable terminal, remove the stop cable upper attaching screw at the inner side of the inboard hinge arm. Then, wrap tape around the cable up to the edge of the stop cable terminal eye as shown by Figure 2.

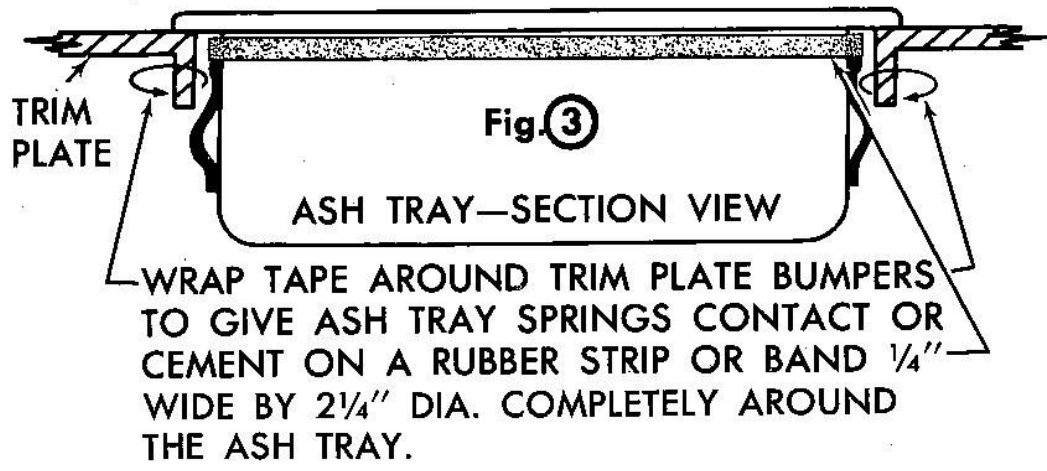
Loose Ash Tray - Front Seat Center Console - 1967 Chevrolet

Occasionally, field reports have indicated a loose center console ash tray. In cases where excess clearance exists, remove the ash tray and add a small amount of electricians tape around both ends of the trim plate bumpers as shown by Figure 3.

A thin rubber strip or band approximately 1/4" wide by 2-1/4" diameter, cemented in place completely around the ash tray, has also been found to be successful (refer to fig. 3).
