# Chevrolet Dealer Service Technical Bulletin

68-T-12

Jan. 2, 1968

Subject: INSTRUMENT CLUSTER GROUND CIRCUIT -  
 1968 PASSENGER CARS

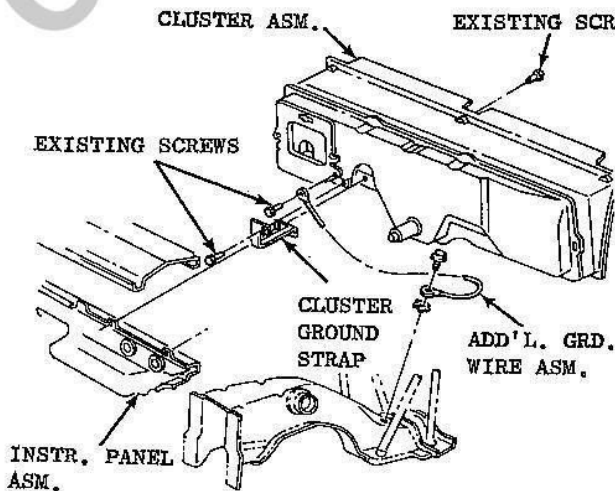
1968 CHEVROLET PASSENGER CAR  
INSTRUMENT CLUSTER GROUNDING

This type complaint is sometimes due to a poor cluster ground circuit resulting from a loose connection at either end of the ground strap. Early production vehicles have one ground strap while vehicles built after October, 1967 have an additional ground wire to insure a positive ground circuit.

3. If malfunction is not corrected, continue diagnosis of the particular circuit affected.
4. If malfunction is corrected, install an auxiliary ground wire between a clock or clock opening screw and a good ground location at dash panel or brake pedal support. Use spade or ring terminals at each end of the wire.
