# Chevrolet Dealer Service Technical Bulletin

68-T-22

Subject: RESTRICTED AIR FLOW - ASTRO-VENTILATION  
SYSTEM - 1968 CAMARO SPORT COUPES

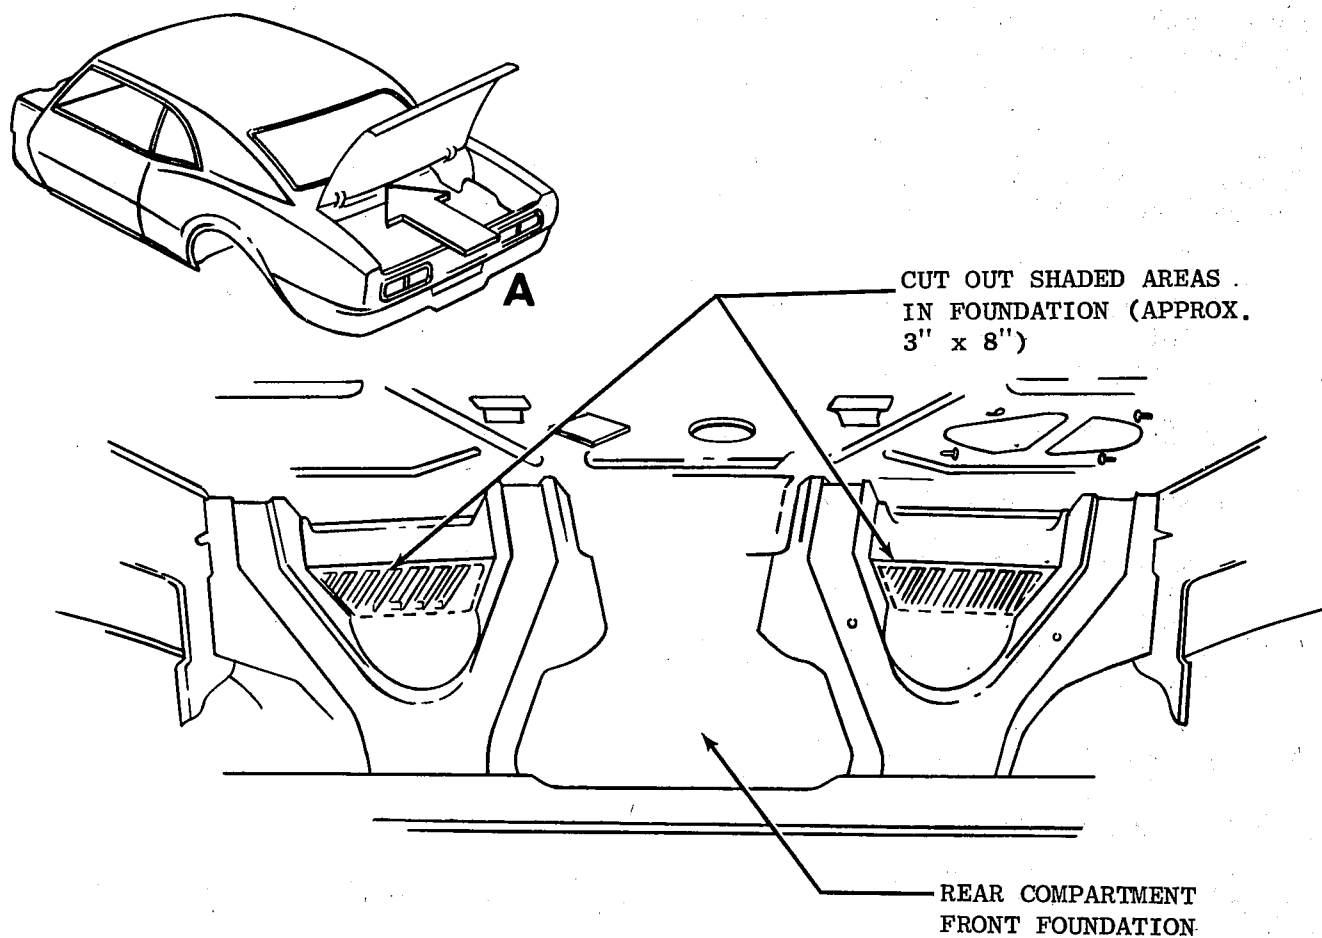
VIEW IN DIRECTION OF ARROW **A**

Some early built 1968 Camaro Sport Coupes with a stationary rear seat back may have inadequate Astro-ventilation air flow due to the lack of "cut outs" in the rear compartment front foundation.

When complaints of poor air circulation are encountered, check the front foundation of the rear compartment (See Sketch) to assure the "cut outs" are removed. If they are still present, perform the following operation to correct.

1. Reaching through the open rear compartment, mark the foundation (with a felt tip pen or suitable marker) to outline pattern as shown by broken line in attached illustration.

2. Remove rear seat back.
3. Remove rear compartment front foundation from the seat back support hooks (3) and lay on a suitable flat surface for cutting operation.
4. With knife (or similar tool) cut along pattern to conform with shaded areas shown in illustration.
5. Replace foundation, seat back and cushion.
