# CAP TRAP

## PUTTING A STOP TO ALL THE DROPS

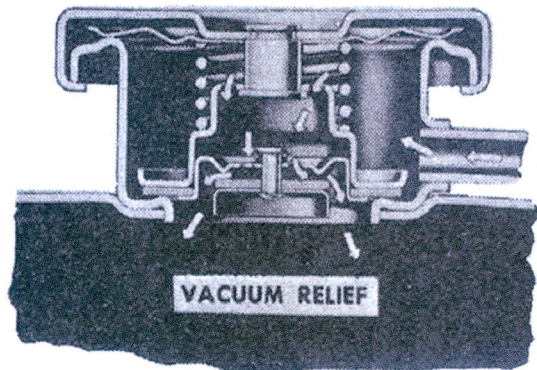
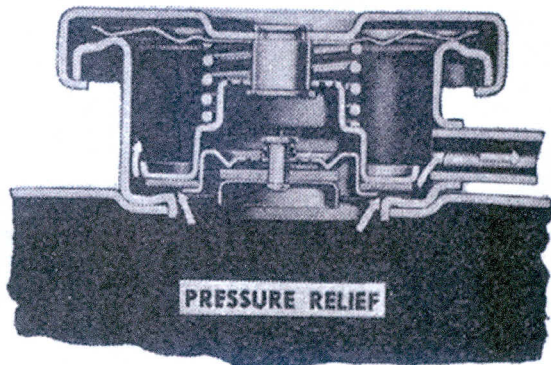
The images below from the Chassis Service Manual shows how the pressure/vacuum-relief radiator cap works. With a hot engine, in pressure relief mode, if the system pressure exceeds the cap's rating, the pressure on the bottom of the cap exceeds the strength of the large coil spring, and the rubber primary cap seal lifts off the lower seal surface in the filler neck, allowing coolant to

escape through the overflow nipple to the coolant recovery bottle. When this occurs, the metal gasket in the top of the cap prevents any coolant from leaking out from under the cap.

When the engine is shut off and the system cools down, the cap is in vacuum relief mode. A slight vacuum is created in the cooling system as the coolant contracts; that vacuum opens the small circular vacuum valve in the center of the bottom of the cap, and the vacuum pulls the expelled coolant from the coolant recovery bottle back into the radiator. If the other seal between the metal gasket in the top of the cap and the top of the filler neck isn't effective, it becomes a vacuum leak, and air is drawn into the radiator instead of coolant from the bottle.

If the caps test OK, check both sealing surfaces on the radiator filler neck. The top surface of the neck seals against the metal gasket in the top of the cap, and

must be smooth and free of nicks. The other seal surface is down about 1/2-inch inside the filler neck, and it seals against the rubber gasket on the spring-loaded portion of the cap; this is the primary pressure seal for the cooling system, and the mating metal seal surface on the filler neck must be perfectly smooth, with no nicks or dents.
