CHEVROLET MOTOR DIVISION
 General Motors Corporation
 Chevrolet Service Department

Chevrolet Dealer Service Technical Bulletin

Re-Issue
 68-T-40

Subject: REPAIR OF RUST AT WINDOW OPENINGS -
 1965-68 PASSENGER CARS EXCEPT CORVAIR

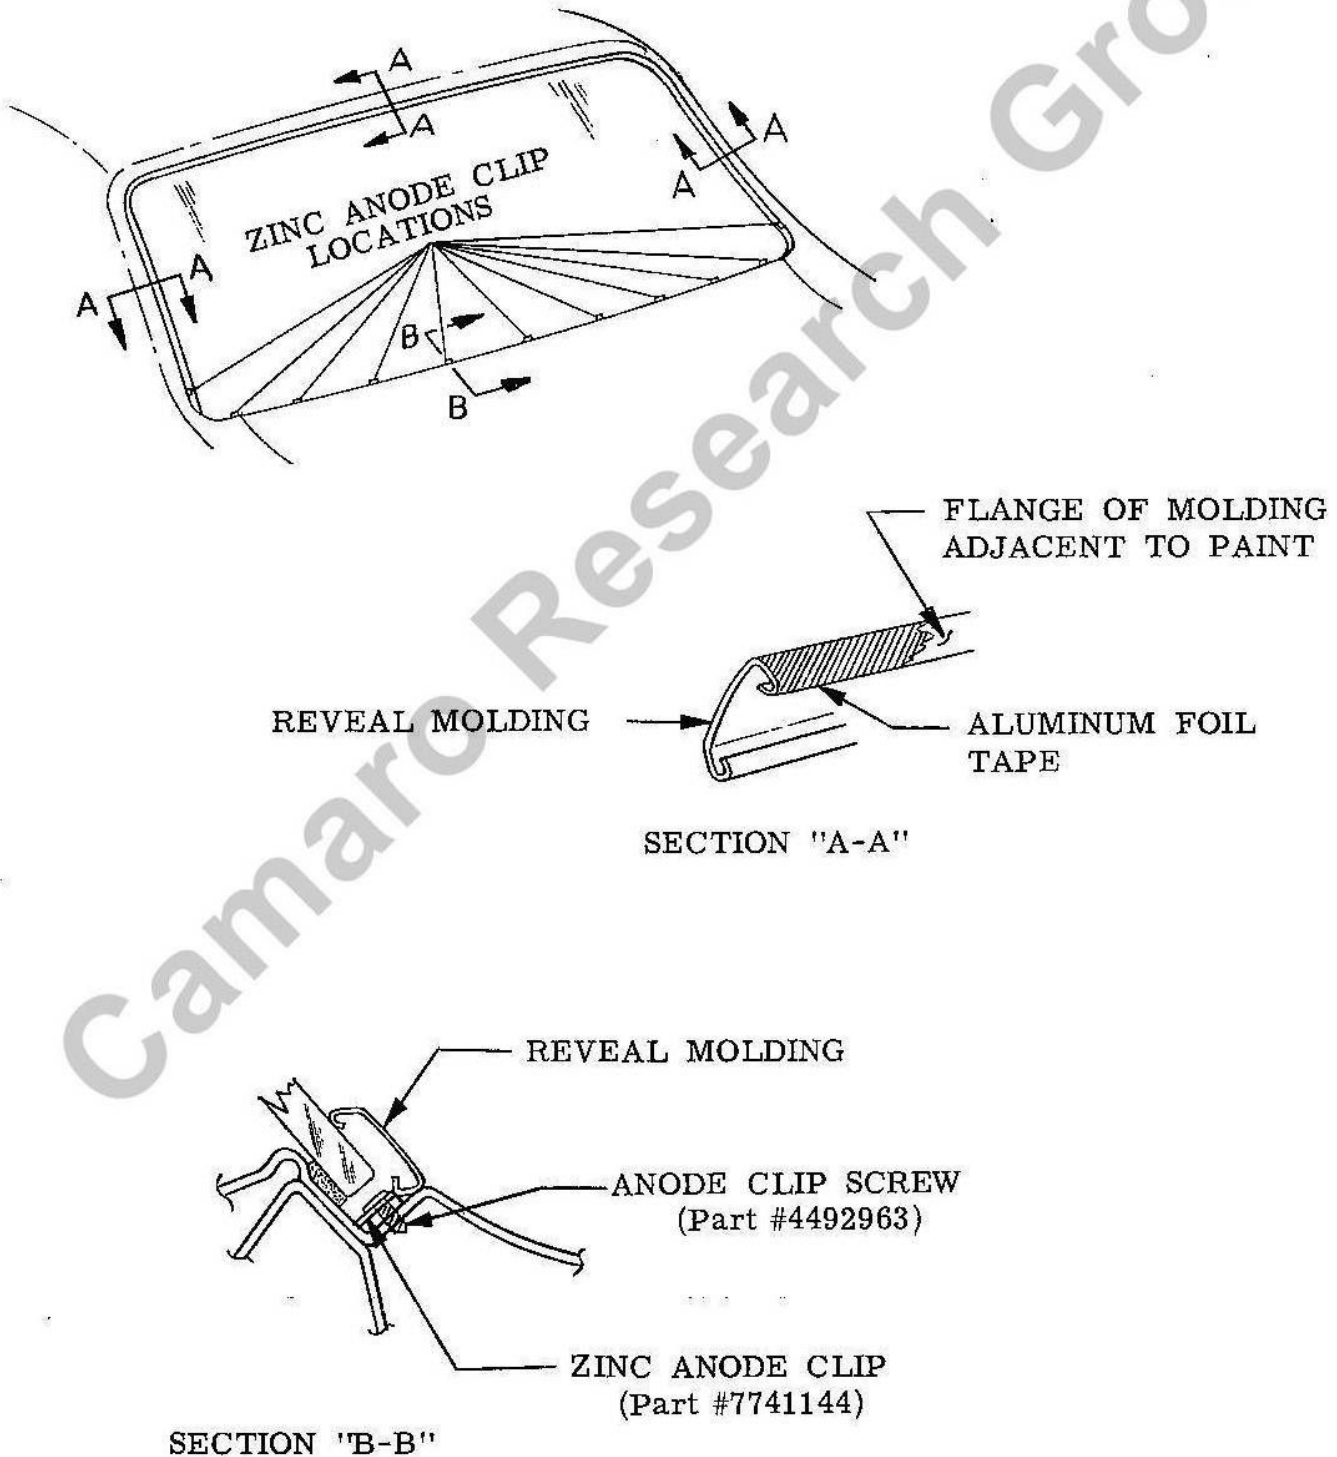
NOTE: This can be done most quickly and efficiently by sandblasting prior to removal of any glass. Exercise care to prevent damage to glass.
5. If minor "rust conditions" are encountered, such as a pin-point size, the conditions can be checked with an application of epoxy base plastic. Follow label directions.
6. If severe "rust-through" conditions are encountered, glass removal is necessary. Then, perform necessary metal replacement and/or solder filling operations as required.
7. Locate and drill holes for anode clip screws and for missing weld studs in rabbet at bottom of window opening (See Figure 1). Space anode clip holes evenly preferably five or less inches apart.

Use No. 44 or 3/32" drill bit. Use care in spacing and positioning anode clips so they will not interfere with reveal molding clips and molding installation. Anode clips are about two inches long.
8. Remove masking which protected paint surfaces. Featheredge cut edges of paint and clean adjacent paint surfaces as required for paint application and blending.
9. Metal condition bare metal surfaces as follows:
 - a. Clean bare metal with metal conditioner for steel (DuPont - VM 5717; Rinshed-Mason #801; Ditzler DX-453; or equivalent). Follow label directions.
 - b. For best results, also apply a zinc phosphate treatment (Granodine No. 50 available by "Special Order" through Ditzler Jobbers or equivalent). Follow label directions.

16. Install window glass if it was removed previously.
17. On 1966 and later models, clean and install reveal molding clips on welded studs. Replace rusted clips.
18. Install zinc anode clips (Part No. 7741144) across bottom of window opening. (See Attached Illustration.) 10 to 15 clips are required depending upon the body style.
19. Clean up all reveal moldings as required. Then apply aluminum foil tape (described below) to entire length of upper and side reveal moldings. Apply tape only on outer flange of molding which is next to paint finish. Position tape at radius of molding (See Illustration) and slick tape down securely to molding. Properly positioned tape should not be evident after molding installation.
